# Peebles

## 4 Bridgegate, Peebles, 1985–87

*by P J Dixon and D R Perry*

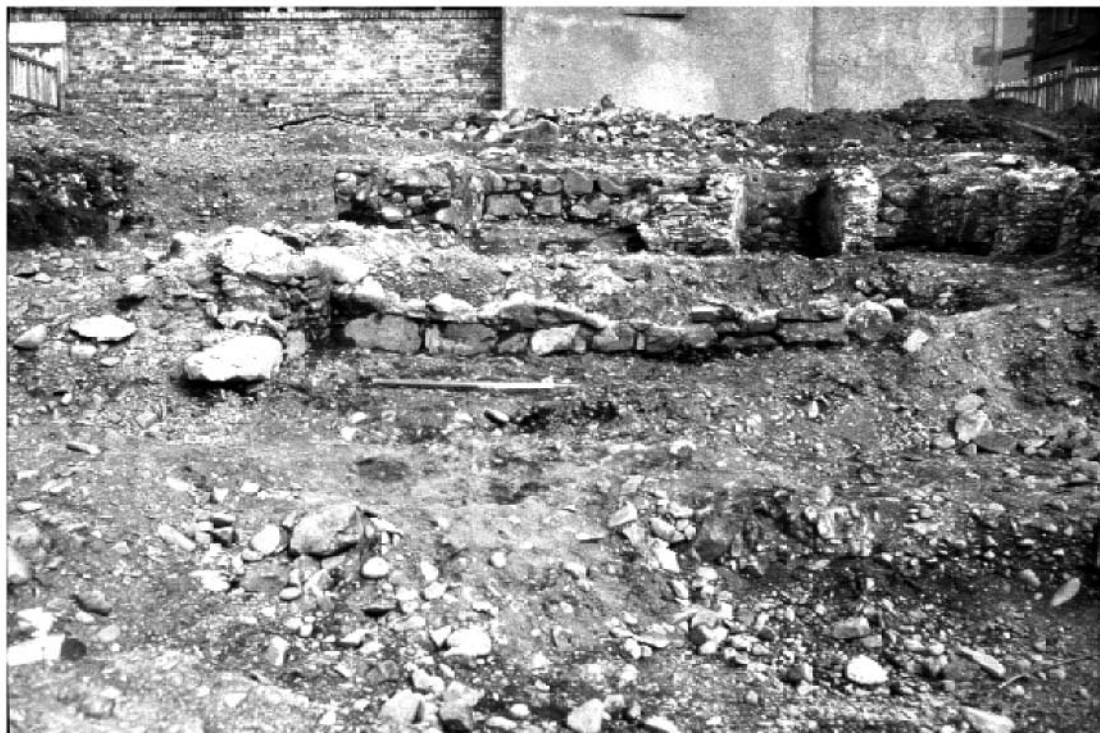
*Illus 32 Bridgewater, Peebles, view of Building 1 from west, with cross-wall in centre and east wall in background*

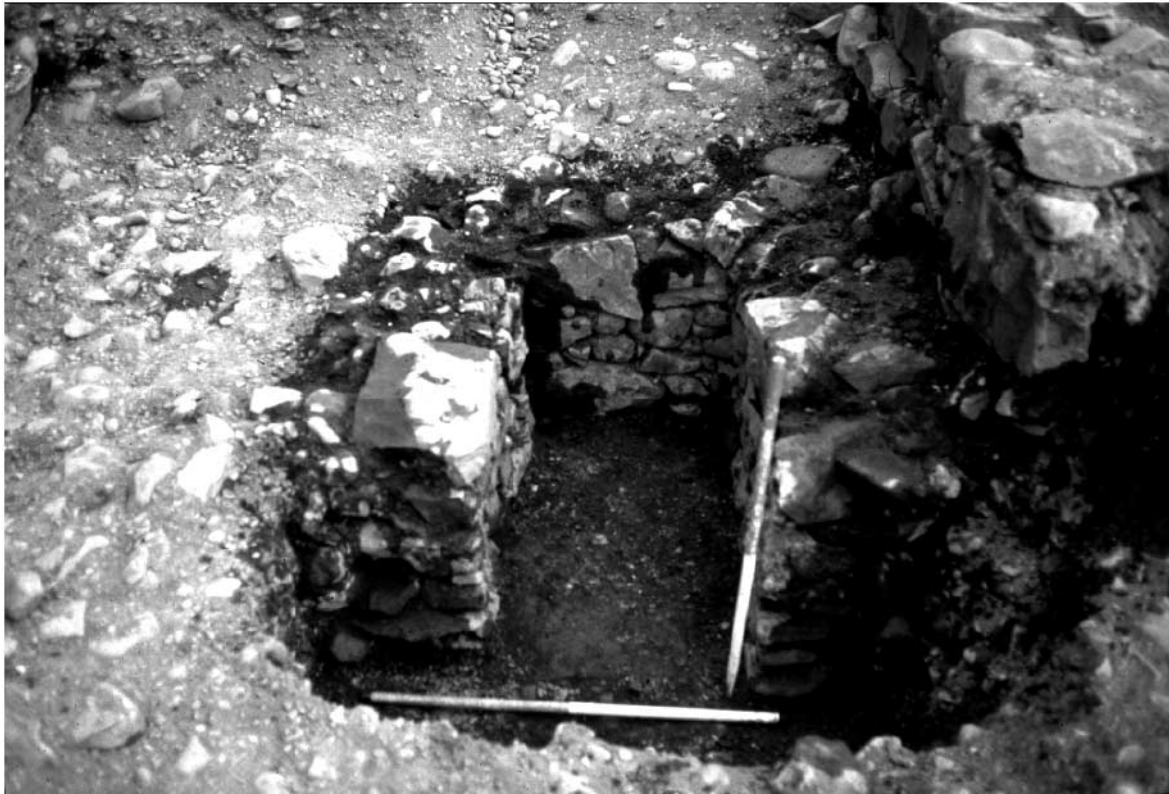
*Illus 33 Bridgegate, Peebles, view of latrine pit of Building 1 from west*

Excavation of the pit revealed a difference between the bonding of the lining of the pit, dark brown silty soil with a few pebbles, from the bonding of the adjacent north wall of Building 1, a 'dirty' gravel. The pit undercut the base of the wall and must have been constructed before the wall. It probably served as a garderobe pit, but there was no conclusive evidence of the date of the construction of the pit, except that it was a primary feature of the building.

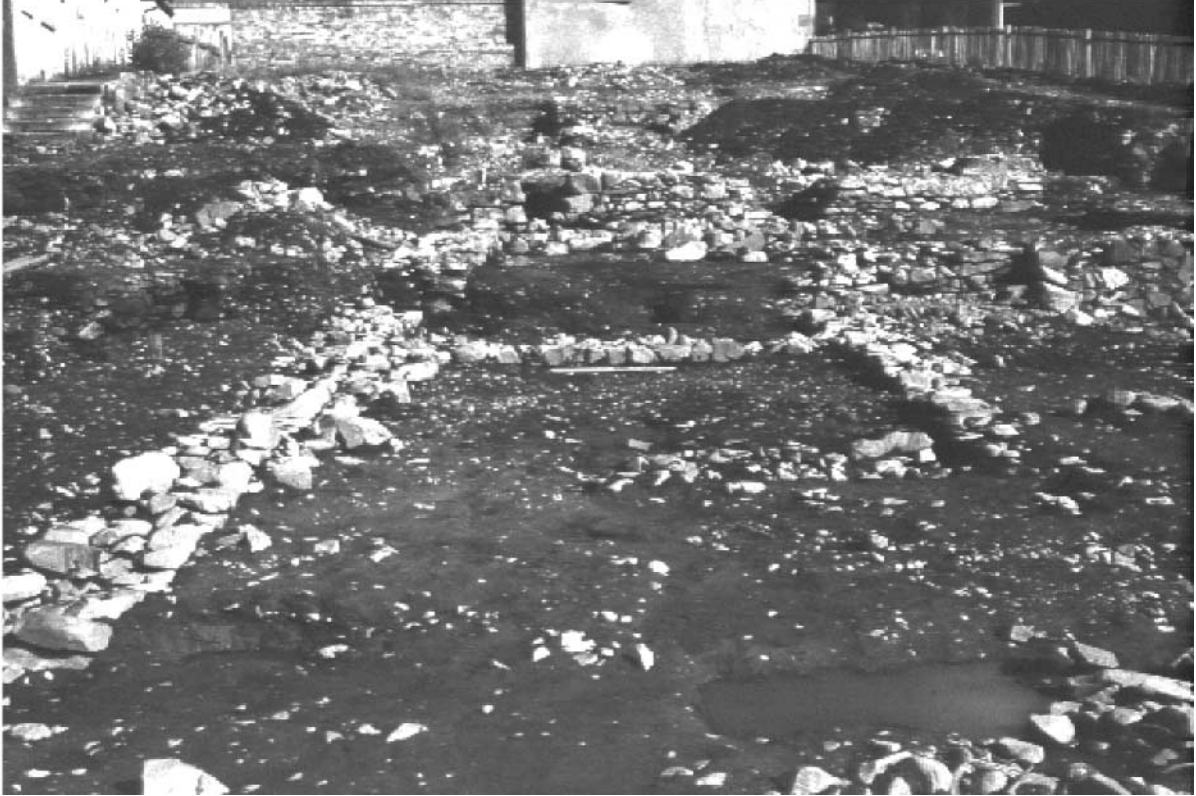
*Illus 36 Bridgegate, Peebles, view of Building 2, Phase 2B from west*

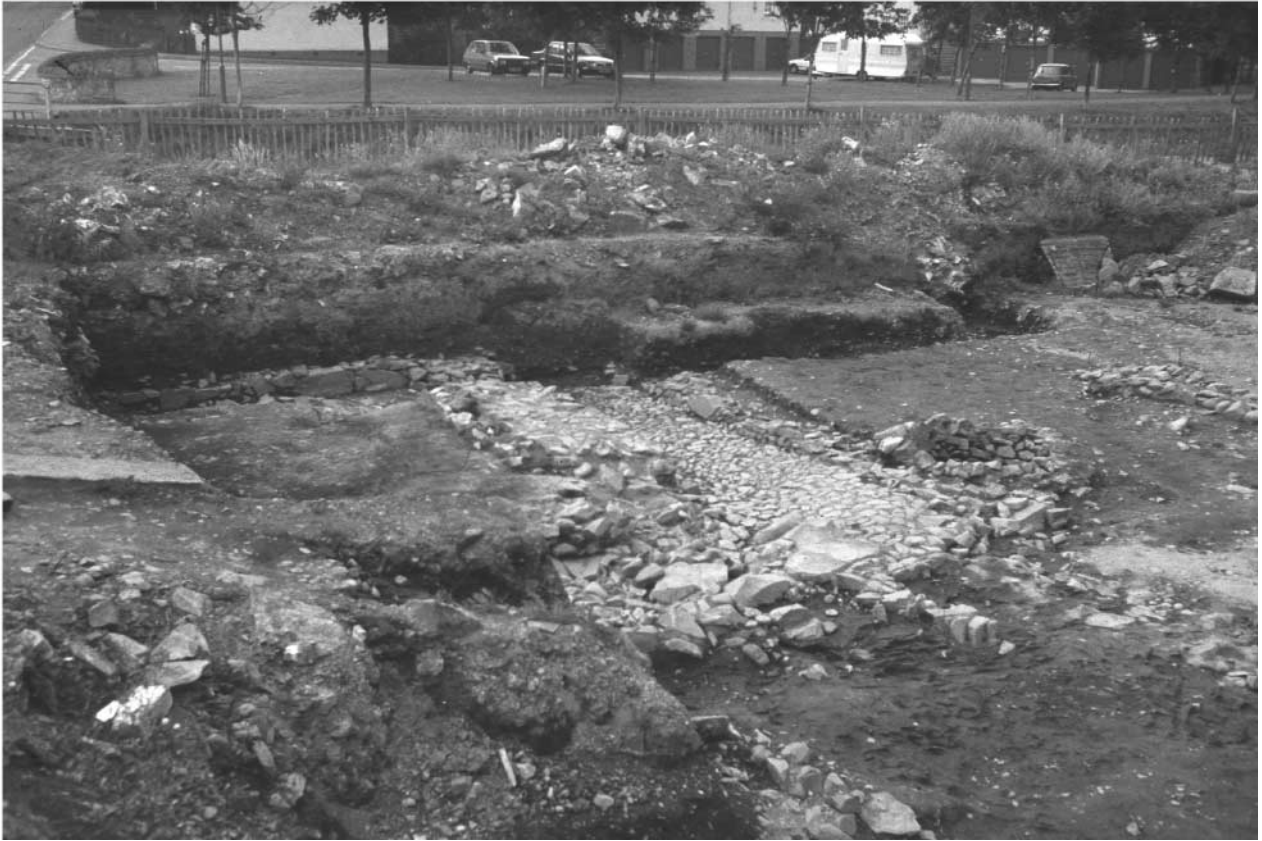
*Illus 40 Bridgegate, Peebles, view of Building 4 from south-east (before extension of excavation to reveal stone pits)*

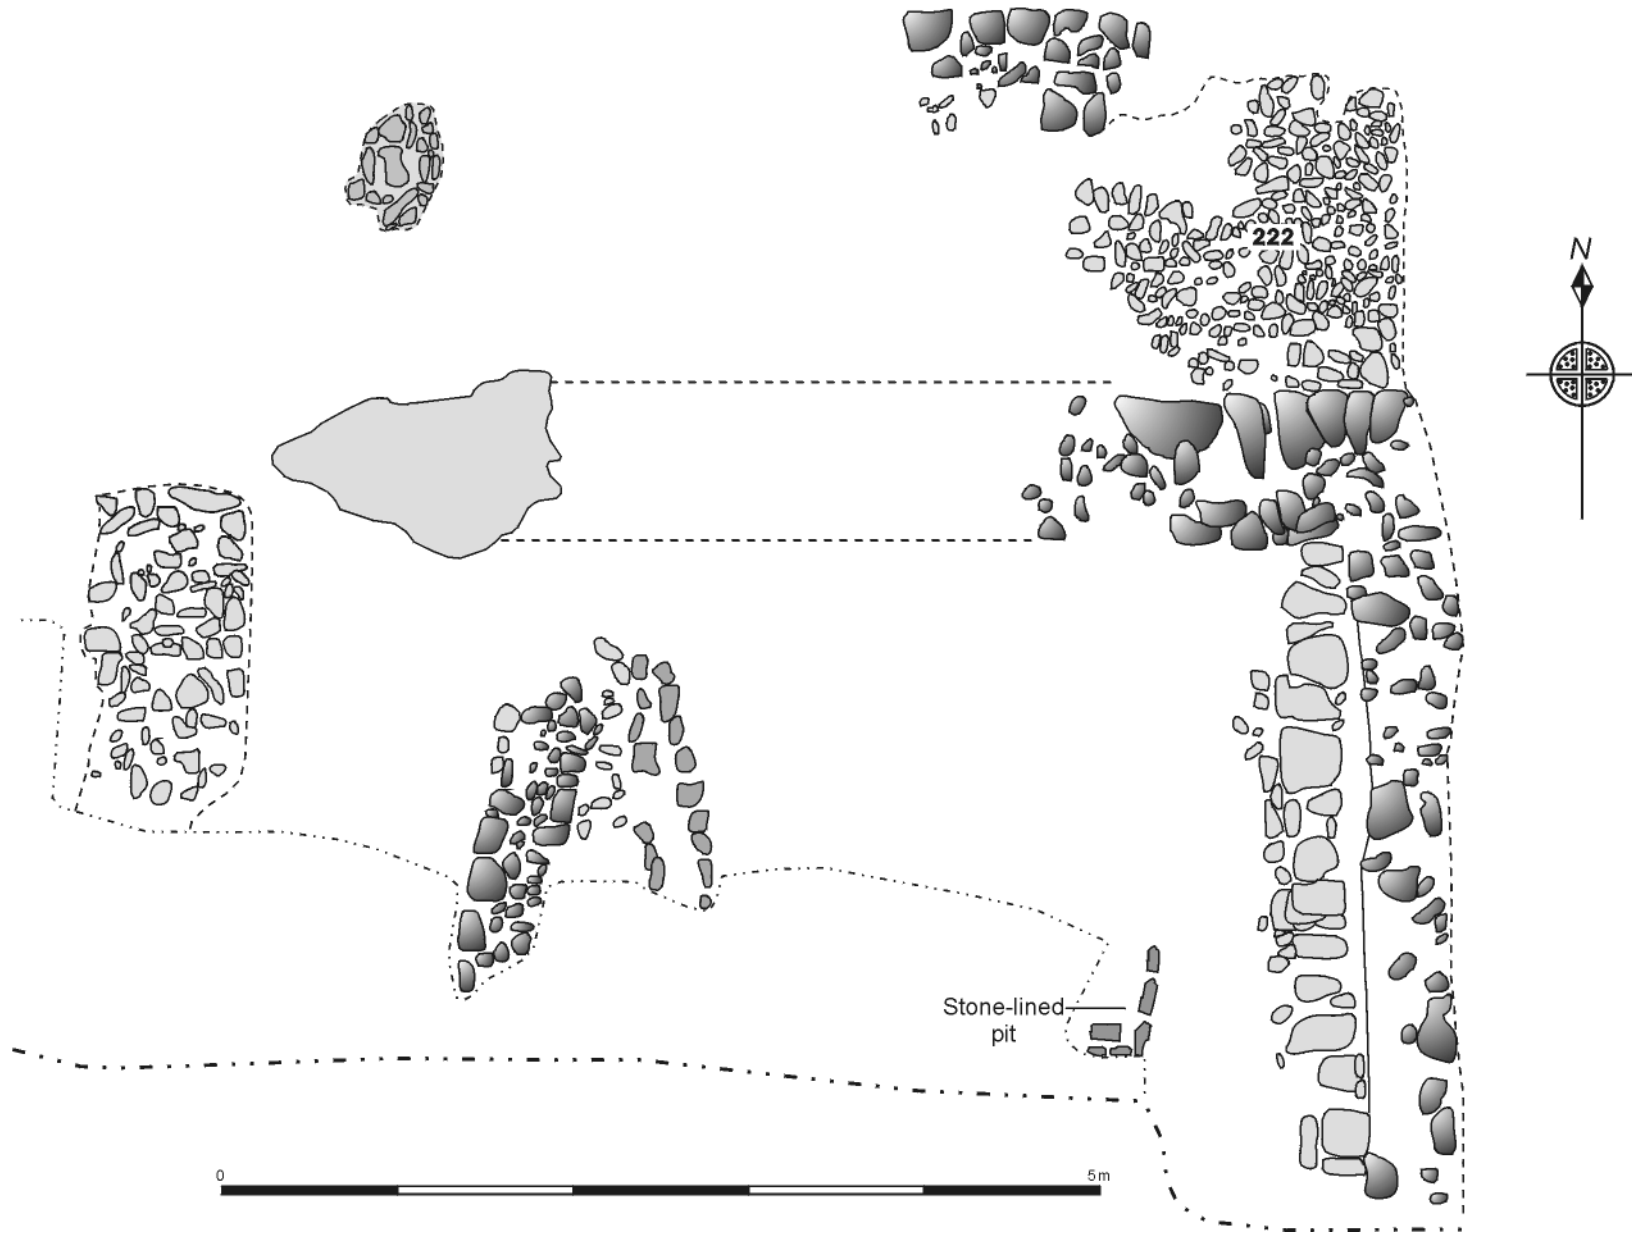
*Illus 41 Bridgegate, Peebles, Building 5*

To the east of the tolbooth were the foundations of Building 5, built against the east boundary wall.

This wall continued in use from the previous phase and was increased in with by 0.5 m on its west side by the addition of a new wall face based on a substantial foundation plinth. Only a fragment of the north wall survived, 1 m long and 0.75 m wide, similar in build to the thickening of the east wall. The wall was set in a shallow trench, in which was a thin layer of yellowish-brown silt. Patches of similar material were found for 5 m west of the surviving stub end, suggesting that the wall may have continued at least that far. No definite west wall was found, although a shallow, flat-bottomed trench, 0.25 m deep, extending into the southern limit of excavation, may represent its foundation or robbing. It was filled with cobbles and gravel in brown, clayey silt. If this was the west wall, the structure would have had a length of about 7.8 m externally and 5.7 m internally.
