9 AN 18TH-CENTURY DESIGNED LANDSCAPE: PERIMETER BOUNDARY WALL SURVEYS AND BOUNDARY EVALUATIONS, *by M Cressey, I Suddaby and S Mitchell*

9.1 Introduction

Dalkeith Park, formerly the formal gardens and grounds of the 18th-century Dalkeith House, is bounded by a stone wall approximately 10km long.

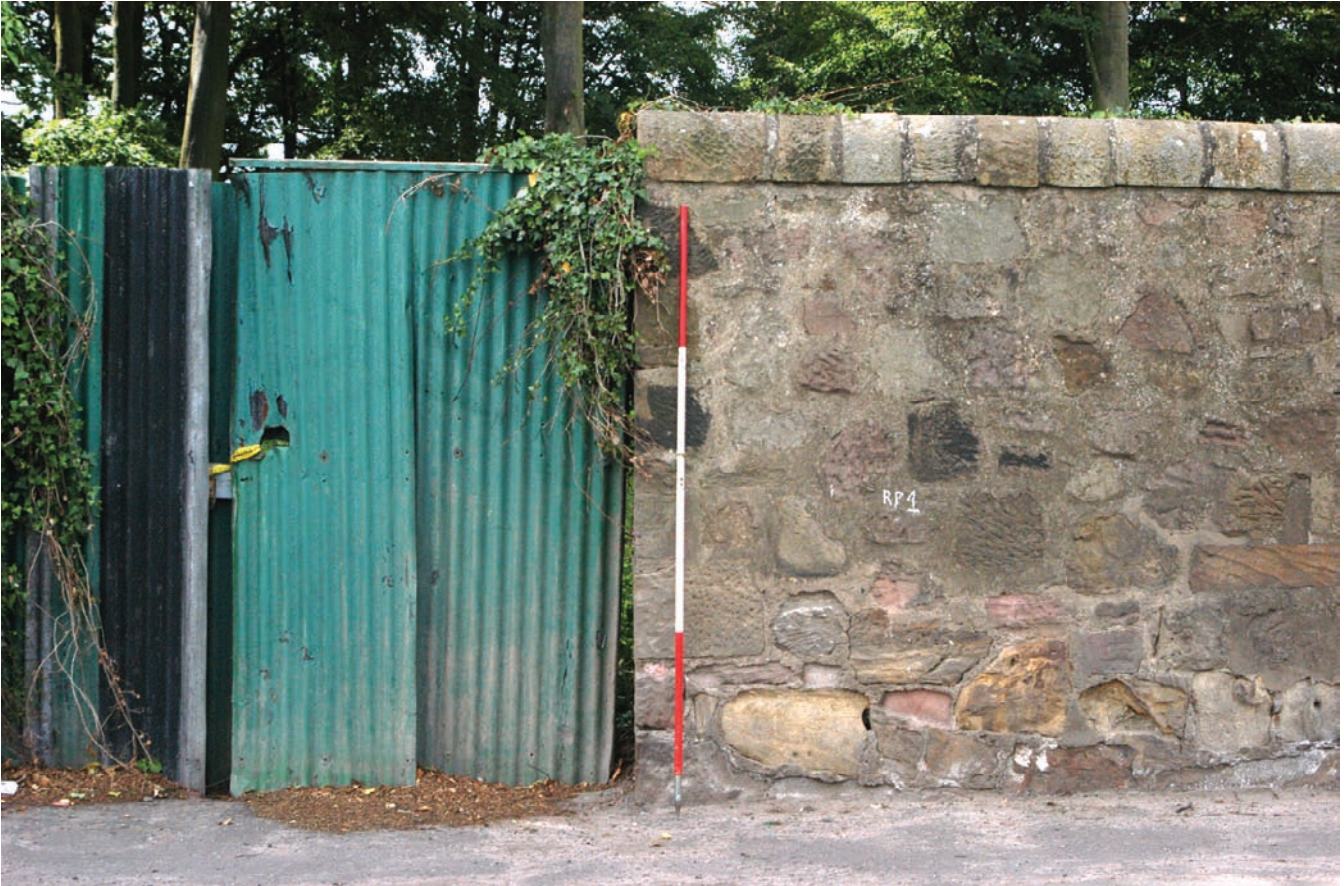
Illus 9.2 Disused entrance in the eastern perimeter wall (recording point 1)

mortar. The coping stones were hewn semi-circular blocks 0.4m wide. The ground on the park side of the wall is lower, giving rise to higher elevations (mean 3m) on this side of the wall in comparison with the roadside, against which the wall is more uniform, with an average height of 2.3m. A gateway and two door openings were the only features of architectural interest (*illus 9.2–9.3*), and these were designed to provide easier access to Salter's Road, the nearest formal access being Smeaton Gate, some 200m to the north towards the village of Whitecraig. The doors are 20th-century in date but the moulded surrounds are original 18th-century features with chamfered ashlar mouldings and droved margins on the quoins.

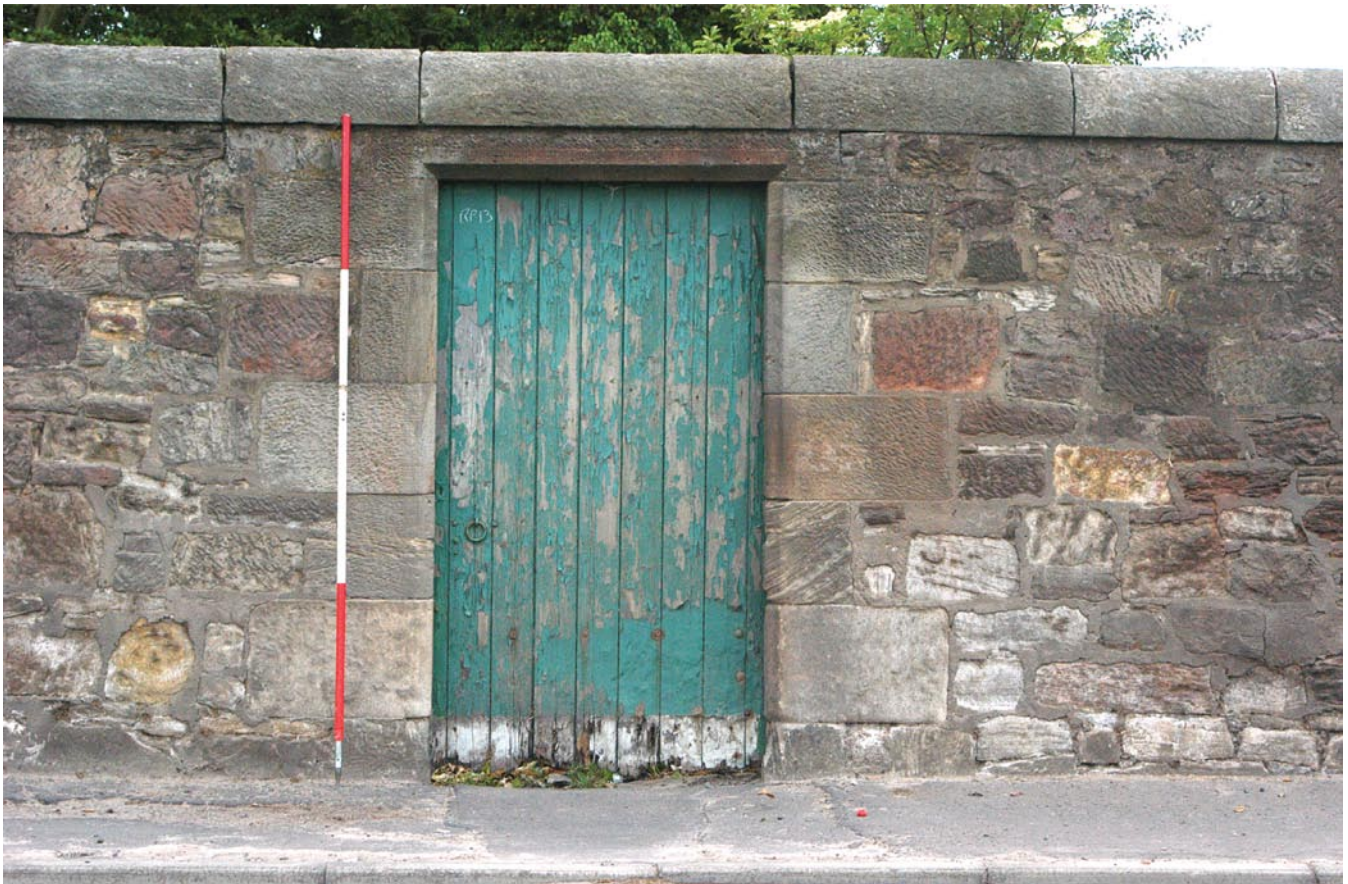
Illus 9.3 Disused doorway in the eastern perimeter wall (recording point 13)

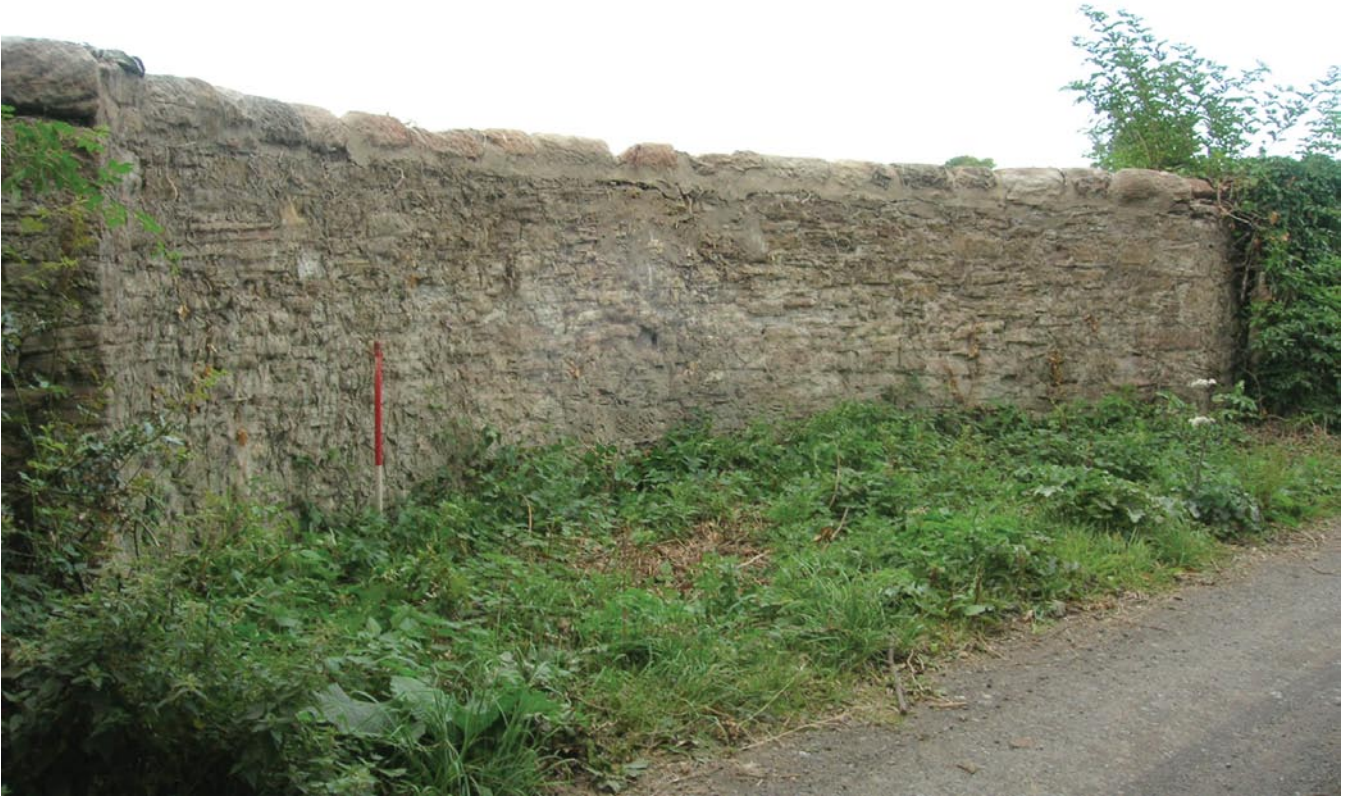
Ivy and other masking vegetation was cleaned away by hand to reveal three sections of walling forming panels about 5m wide (sample areas 1–3). Included within the group was a recessed area that is suggested to have been an ornamental seating area (*illus 9.4*). It is highly probable that this position afforded panoramic views over the River Esk towards Carberry Hill and the landscape beyond during the late 18th or early 19th century. A 20th-century plantation restricts this view today.

Illus 9.4 (above) Curving feature in the western perimeter wall

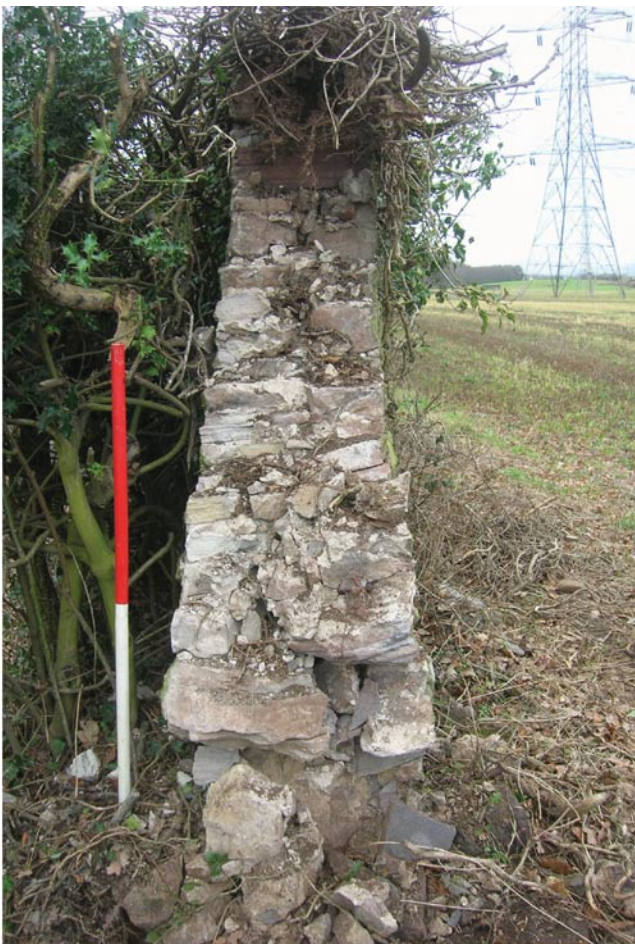
tions made following the demolition of the western boundary wall confirmed a double-skin construction with rubble-filled cavity (*illus 9.5*). Measurements obtained from the wall stubs confirmed that the wall was slightly wider at the base (0.55m), in comparison with the wall heads that were uniformly 0.4m. cursory examination of the foundations exposed when the wall was demolished confirmed that the foundation depth was 0.5m deep with rubble resting directly on top of subsoil.

Illus 9.5 (left) Section through the western perimeter boundary wall showing double skin with rubble core

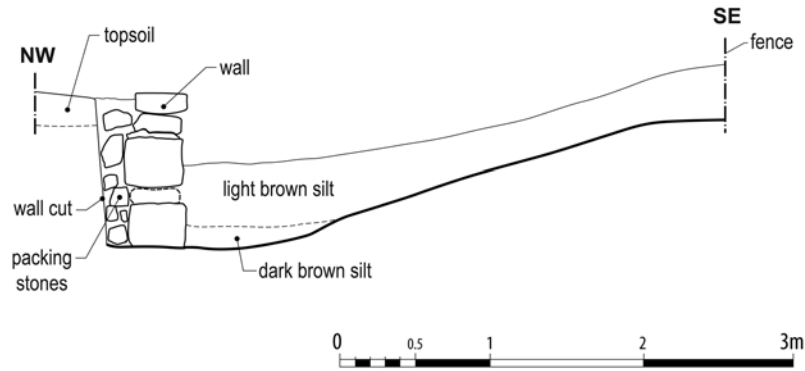
Illus 9.6 Section drawing of the Castlesteads boundary

The wall and ditch attained a width of 4m and a height of 1m (illus 9.6). The upper stones protruded slightly above the level of the topsoil to the north-west. The sandstone forming the wall was similar to that used in the perimeter wall but the size of the blocks was larger and they were more regular in their shape (illus 9.7). The wall width was 0.4m and the vertical face was built in front of a packing deposit of smaller stones which filled the sloping cut and assisted drainage. The ditch contained two silty fills from which no finds were recovered.

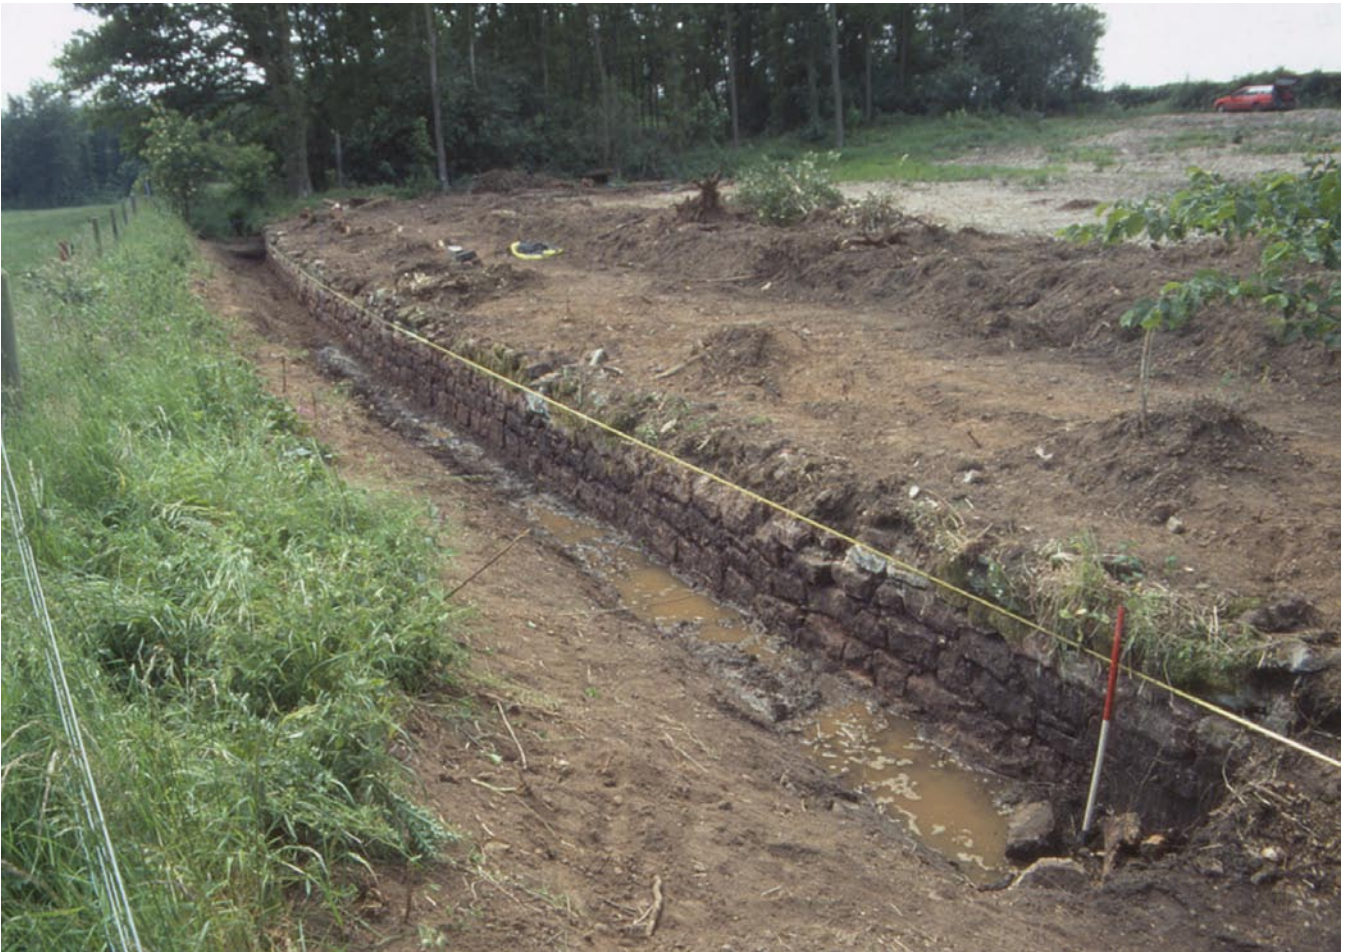
Illus 9.7 General view of the Castlesteads boundary
